2024 restoration report of the Project Clear pipeline path and adjacent areas

Prepared by Caity Sims, Restoration Coordinator – Project Clear

March 2025

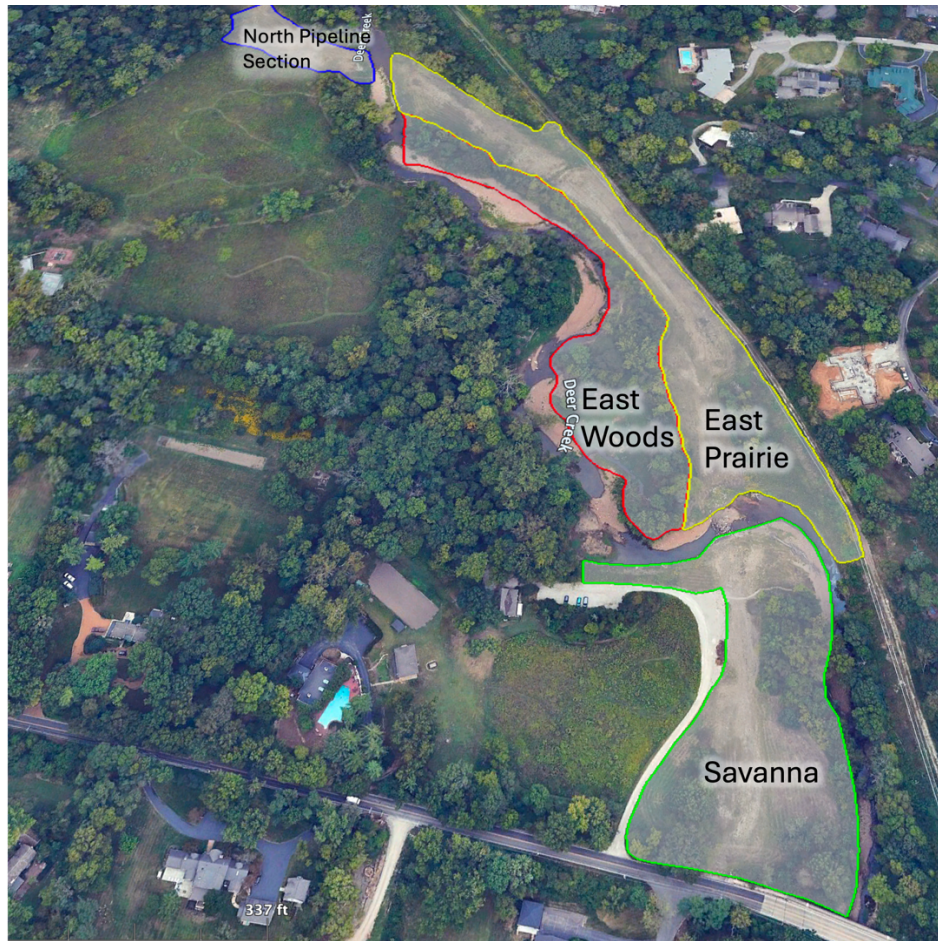
Figure 1. Project Clear restoration unit boundaries and adjacent East Woods restoration unit.

Long-term Goals: Tallgrass bottomland prairie will be reconstructed on the northern and eastern sections (East Prairie) of the path. The northern section of the path will eventually be recombined with the North Prairie restoration unit. MSD has a 7.5 ft permanent access easement on either side of the pipeline, thus planting trees and other woody species should be avoided in these areas. The southern section of the path (Savanna) includes areas that were lawn, and will be reconstructed into bottomland savanna (i.e., grassland species with about 30% tree canopy cover).

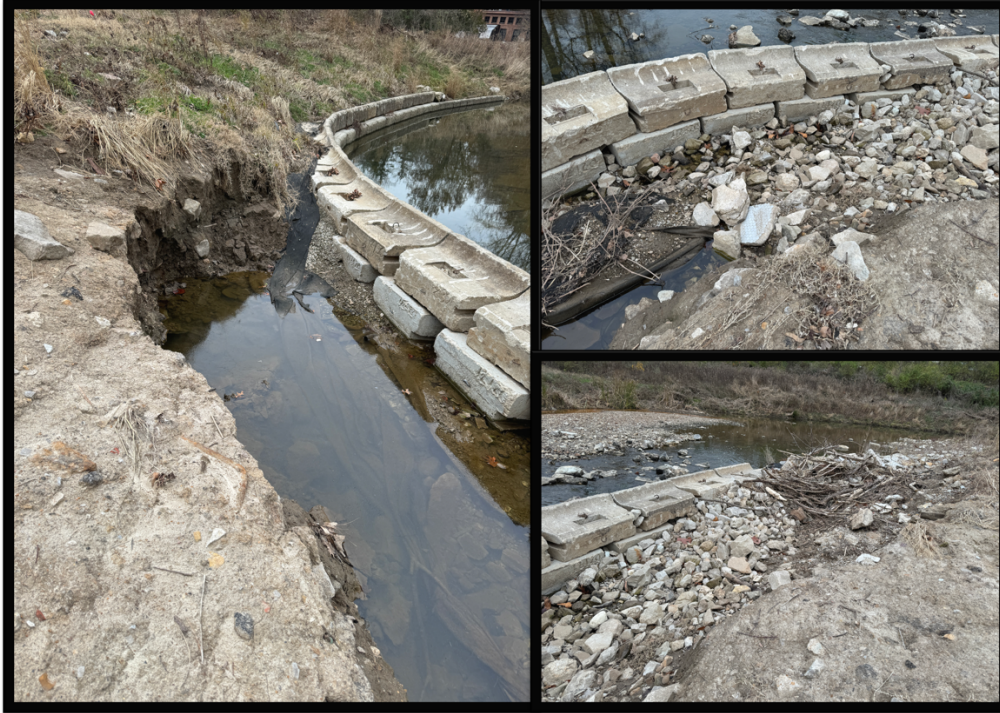
Figure 2. Severe scouring behind the toe wall on the banks of Deer Creek. Pictures taken on November 27, 2024.

Some of the seeded areas are more prone to seasonal flooding, such as the southern section of pipeline path where Deer Creek's channel bends rapidly to the east and then back toward the south. A concrete bank retaining toe wall installed at the bend of the creek by MSD after Project Clear construction has been an ongoing issue since its installment. The area behind this concrete wall has been eroded several times after flooding from the creek (Fig. 2).

On April 2, 2024, heavy rains caused Deer Creek to quickly rise to a height of 14.32 ft. After flooding, topsoil laid down after pipeline construction was scoured away, leaving degraded soil and large chunks of limestone exposed. Many plugs planted by contractors in 2022, were washed out. A portion of the pipeline that connects to a manhole was exposed as well. After this flood event, staff assumed any native plant species seeded in the prior winter were not able to persist. This specific flood event significantly eroded the hole behind the concrete toe wall along the Deer Creek bank. Due to several constraints, the creek bank was not stabilized for the remainder of the season. A second major flood event happened on November 5, 2024. After heavy rains, the creek reached a height of 15.8 ft. Further erosion of the soil and creek banks occurred after this event. Solutions for creek bank stabilization in that area will take place in 2025.
